The Impact of Climatological Factors on the Multifaceted and Multisystemic Deficiencies of Building Anatomy

Md Azree Othuman Mydin[1,*], Norliana Sarpin[2,3], Rosmiza Mohd Zainol[4], Ruba Odeh[5], Mohd Nasrun Mohd Nawi[6]

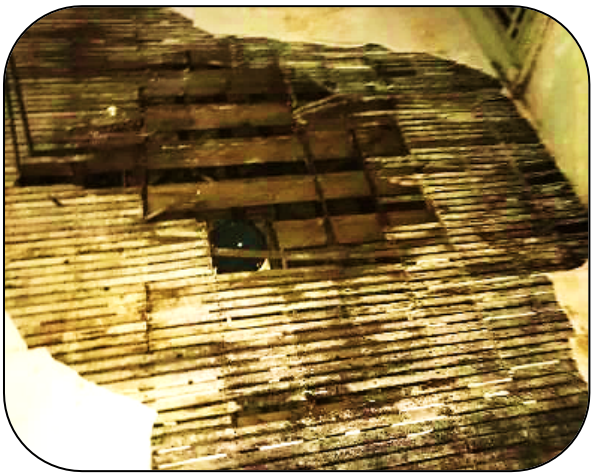
Fig. 6. Sign of mold spores

Outdoor sources of mould spores can transmit and cause indoor contamination, heightening the likelihood of mould growth on surfaces and degrading the quality of indoor air. Weather phenomena, such as wind and precipitation, have the potential to impact the dissemination of mould spores in both indoor and outdoor environments. Figure 6 shows the sign of mold spores. Aerial fungal spores can be transported by atmospheric currents, water, or insects from external origins to inside settings [43]. Upon landing on a damp surface within the building, these spores have the ability to initiate growth and reproduction.
