Appraisal of the Aetiology and Pathology of Soil Settlement-Related Building Defects and Failures

3.1 Case Study 1: Shop Lot

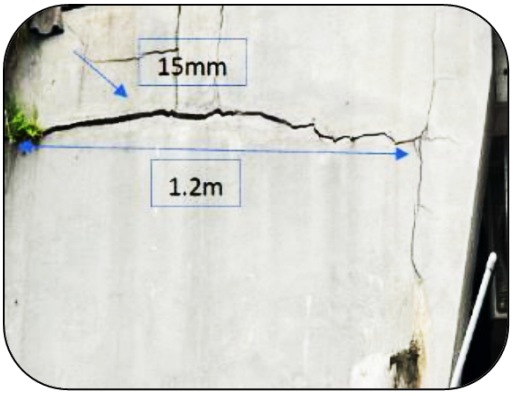
After making observations, the researcher makes measurements of the structure and any defects that occur (Figure 6). The width of the structure is 1.5 m. For the crack on the structure, the researcher estimates the crack is 15mm wide. This size of crack is required to open. Repointing the

external brickwork might be needed, or in some cases, it might need to be replaced. The length of the crack that occurs is 1.2m from the actual width of the structure.

Fig. 6. Detail of defects

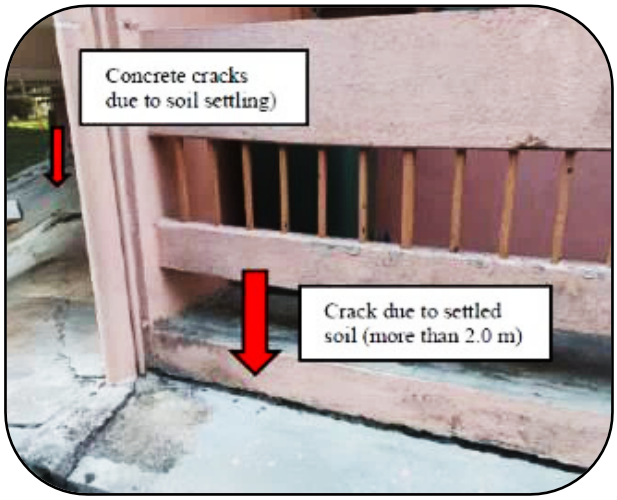
Observation and study reveal that natural factors, such as the earth's steep shape, contribute to this phenomenon. Inadequate drainage systems or unsuitable geological conditions can weaken the embankment's strength and stability. Furthermore, due to the seasonal climate, soil moisture in a liquid or gaseous state moves from hot to cold temperatures and accumulates, which destroys the embankment [21]. The presence of horizontal fissures in the building is attributed to soil movement produced by settlement of the ground. The diagram depicts apron fractures in the building's foundation caused by ground subsidence and the slope adjacent to the structure. The crack measures more than 2.0 m in length (Figure 9). The occurrence of concrete cracking in the curved section is attributed to ground displacement in the surrounding area. The crack has a width of 10 mm (Figure 10).

Fig. 8. Concrete cracks due to soil settelement

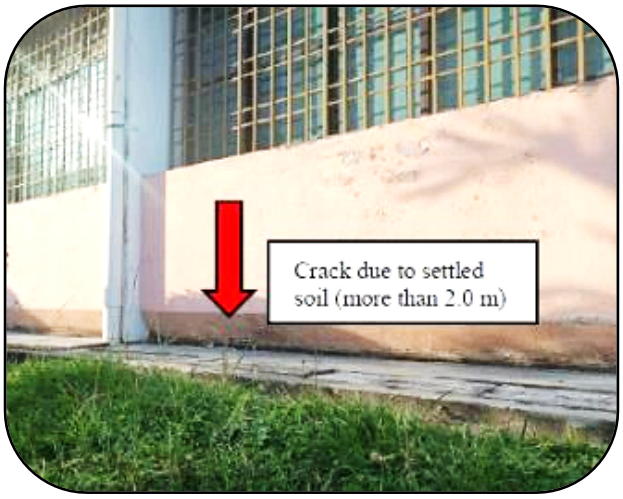
Fig. 9. Visible cracks at wall due to soil settelement

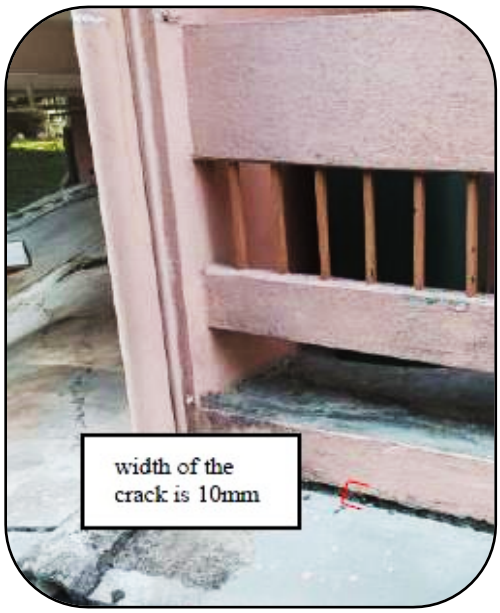
Fig. 10. Width of crack of approximately 10 mm

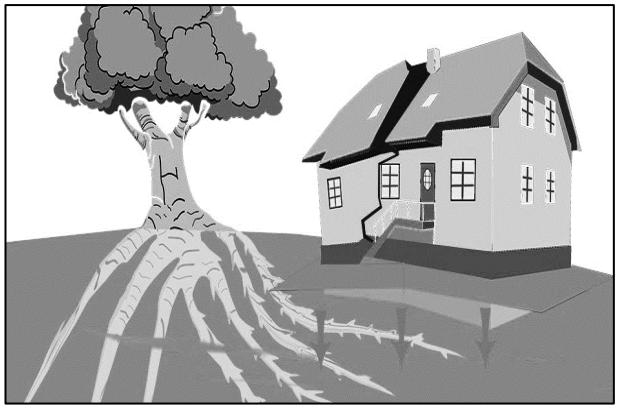
Vegetation such as trees, plants, and bushes can have a negative impact on the stability and integrity of foundation as shown in Figure 13. Additionally, the presence of tree roots can result in structural damage to structures, including the formation of cracks as demonstrated in Figure 14. Large trees, in particular, are responsible for depleting moisture from the underlying soil beneath your foundation if they are planted near it. Plants require water for their survival, and their roots instinctively search for moisture. Shrinkable cohesive soils can cause excessive water withdrawal from the foundation by plants. This leads to soil shrinkage and foundation subsidence. It is predictable that various species have varying capacities for water absorption. Typically, when determining how far to plant trees from a property, it is advisable to consider both the length of the roots and the height of the tree, as they are usually similar [28].

Fig. 13. Trees can negatively affect the stability and integrity of the foundation

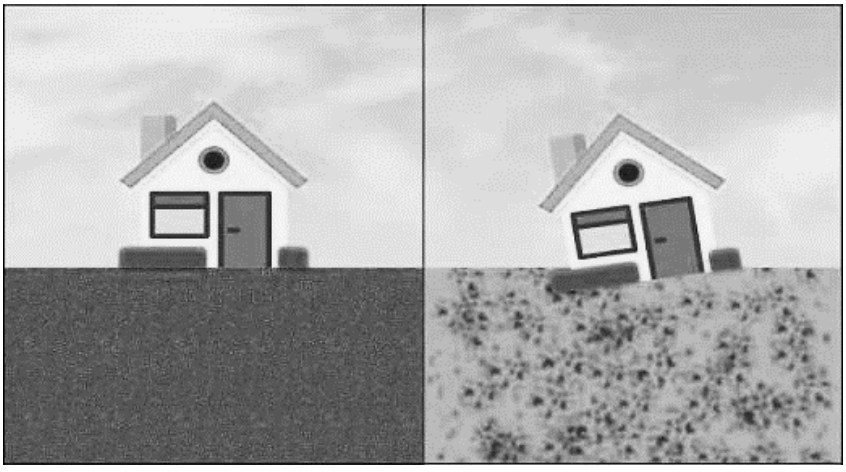
Lot preparation is a significant aspect of the home building process when constructing a new foundation. Good soil compaction (Figure 19(a)) is an essential aspect of land preparation, whether the builder is excavating to create a basement or crawl space or constructing a slab foundation with footings directly on the soil. Inadequate soil compaction (Figure 19(b)) by the builder might result in insufficient support for the foundation, hence causing settling problems.

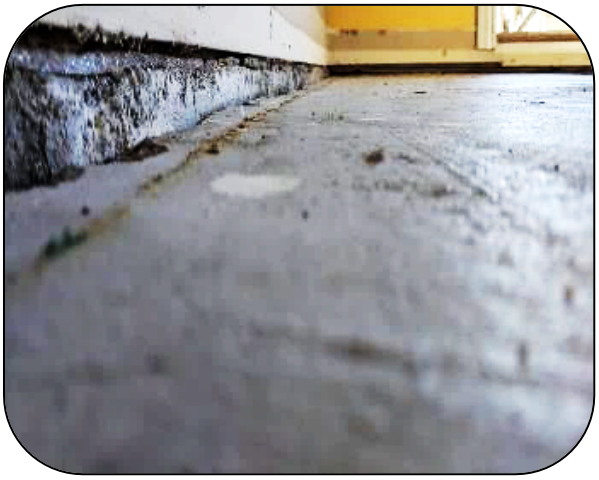
If the house's foundation experiences settlement, it can cause the flooring in the living room to slide inward or become unequal or undulating due to a loss of stability [43-45]. Figure 24 illustrates the sloping floor, whereas One may observe pronounced displacement in your everyday activities, or one could be using a leveling instrument to ascertain irregularity that is often imperceptible [46-48]. Severe structural deteriorations may also result from exposure to heat and elevated temperatures [49, 50]. The behavior of different types of concrete will vary as a result of their distinct engineering features.

Fig. 24. Sloping floor
